FIRE STATION CONSTRUCTION AINKAWA, IRAQ

SIGIR PA-06-036
APRIL 12, 2006

SUBJECT: Report on Project Assessment of the Fire Station Construction, Ainkawa,
Iraq (Report Number SIGIR-PA-06-036)

Fire Station Construction, Ainkawa, Iraq

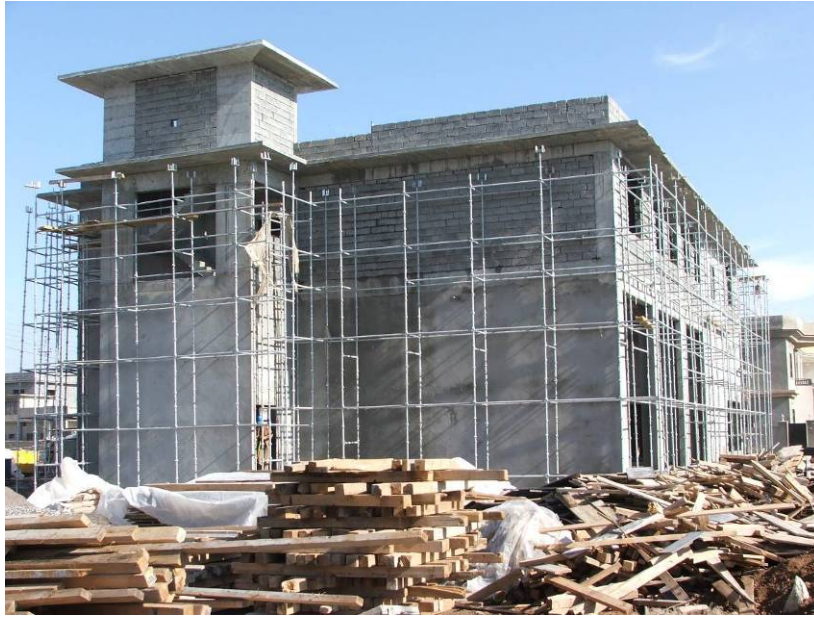
Site Photo 2. Exterior view of the Ainkawa fire station

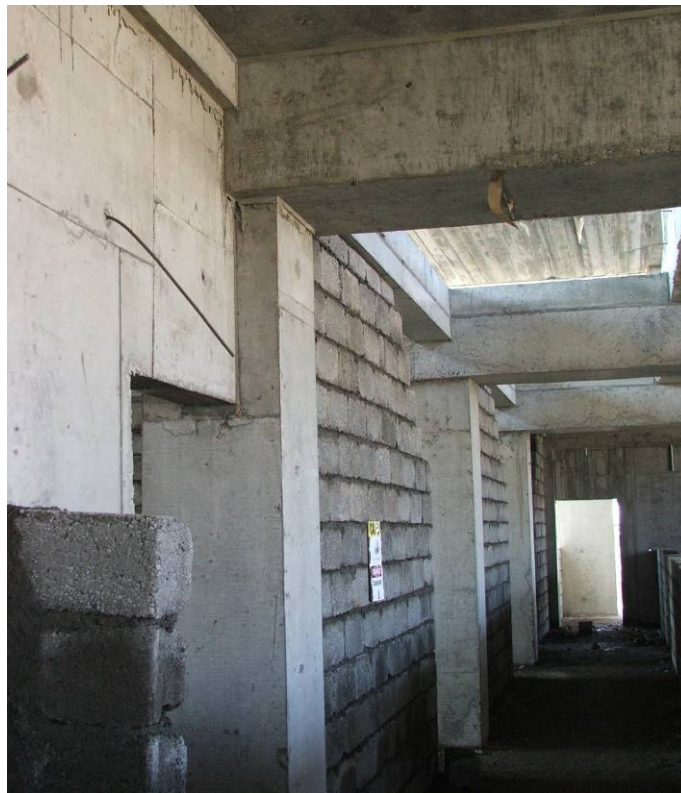
Site Photo 3: Interior structure showing concrete block walls, columns, and beams

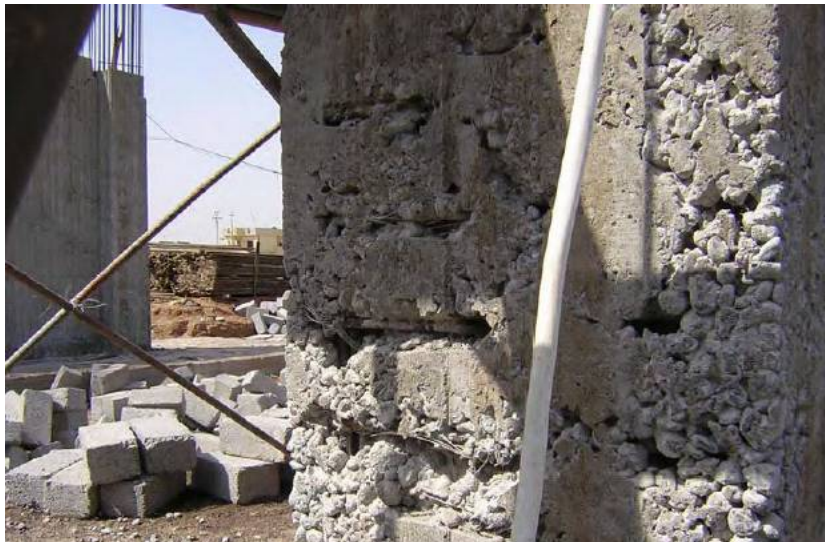
The USACE RE informed us there is a serious issue with the quality and possible structural integrity of the reinforced concrete shear walls, columns and beams located in Level 1. Parsons constructed these structural members in Level 1 in early May 2005. There were considerable voids in the reinforced concrete on this level, particularly in the columns. The first three meters of the columns contain significant honeycombing³ resulting from improper placement and poor vibration of the concrete. The contractor batched the concrete onsite utilizing a small drum mixer (less than 1 cubic meter (m³) in size). The mixer produced one small batch at a time without proper controls in place to assure the same mix ratio was utilized for every batch. The process used by the contractor to fill the forms with concrete was similar to a "fire brigade," where buckets of concrete were passed down a line of workers, up a ladder and poured into the form from the top. By pouring the concrete from the top of the forms, vibrators could not reach the bottom. As a result, the concrete could not be uniformly distributed, especially in the lower areas of the column or wall. Site Photos 4-8 show honeycombing found in columns in Levels 1 and 2 after concrete placement.

Site Photo 4. Honeycombing/exposed reinforcing steel in concrete column on Level 1 - Photo provided by USACE.

³ Honeycombing refers to the voids left in the concrete due to failure of the mortar to effectively fill the spaces among coarse aggregate particles (*American Concrete Institute*).

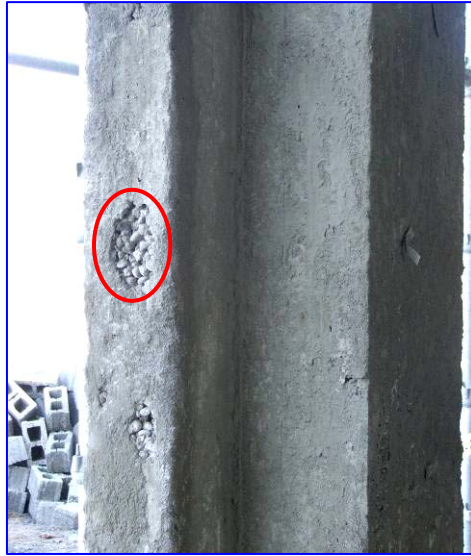
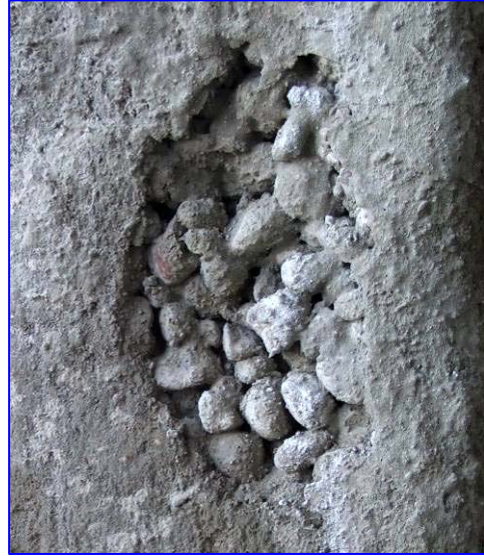
Site Photo 5. Honeycombing after surface coating

Site Photo 6. Closeup of Site Photo 5

Site Photos 5 and 6 show the honeycombing on an exterior t-shaped stub wall after the gypsum plaster surface coating had been applied.

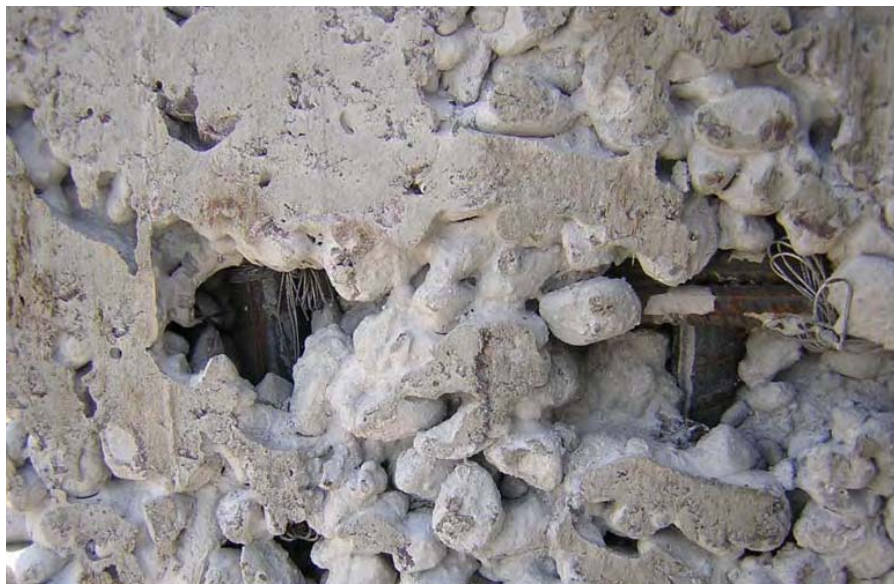
**Site Photo 7. Honeycombing and exposed rebar in concrete on Level 1.
Photo provided by USACE.**

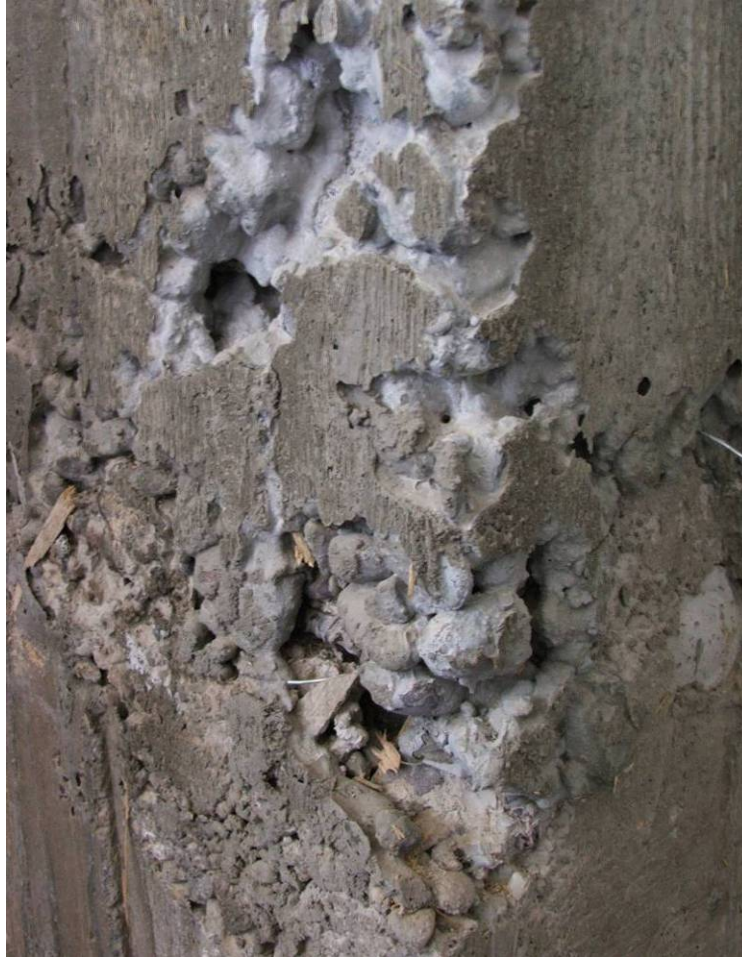
Site Photo 8. Honeycombing on Level 2 column

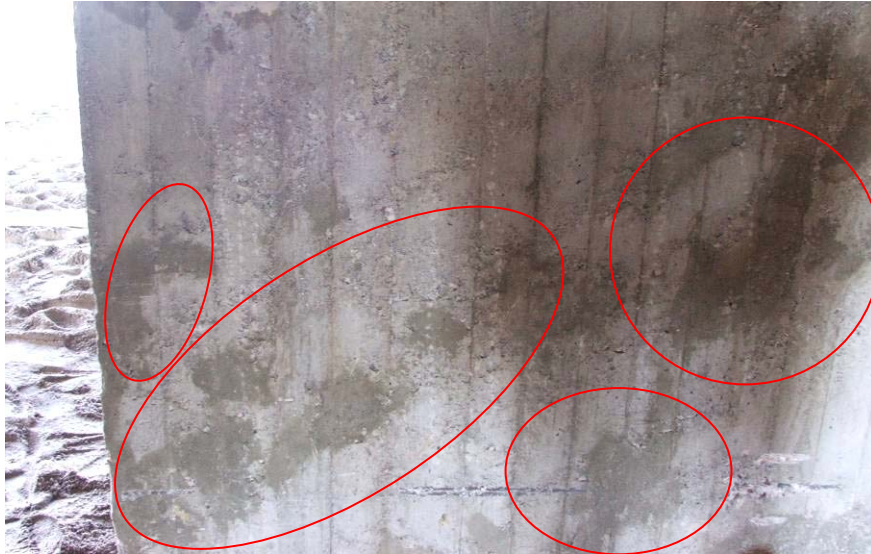
the USACE Administrative Contracting Officer (ACO), Parsons' quality control engineer instructed the subcontractor to repair the concrete defects using an epoxy grout. However, Parsons' home office quality control engineer in Baghdad directed the subcontractor to make the repairs using a rich cement and sand mortar mix. Subsequently, the contractor patched the honeycomb areas utilizing the rich cement and sand mix as illustrated in Site Photo 9. The USACE RE was not satisfied with this method of repair, favoring instead the use of an epoxy grout to fill the voids in the concrete.

Site Photo 9. Rich cement-sand patches made on a Level 1 shear wall

2. This directly relates to Recommendation 1. Mortar patches were made to the walls and columns to correct the defects in the concrete. The district has formally directed the contractor to certify that the sheer walls and columns are structurally sound and consistent with the design specifications on two occasions; 17 June 2005 and 4 April 2006. The contractor was asked to respond within 15 days of receipt of the latest letter.
3. On 27 March 2006 and again on 6 April 2006, GRN requested GRD-PCO (Programs Directorate) determine if the task order requires driveways, sidewalks, and perimeter walls.

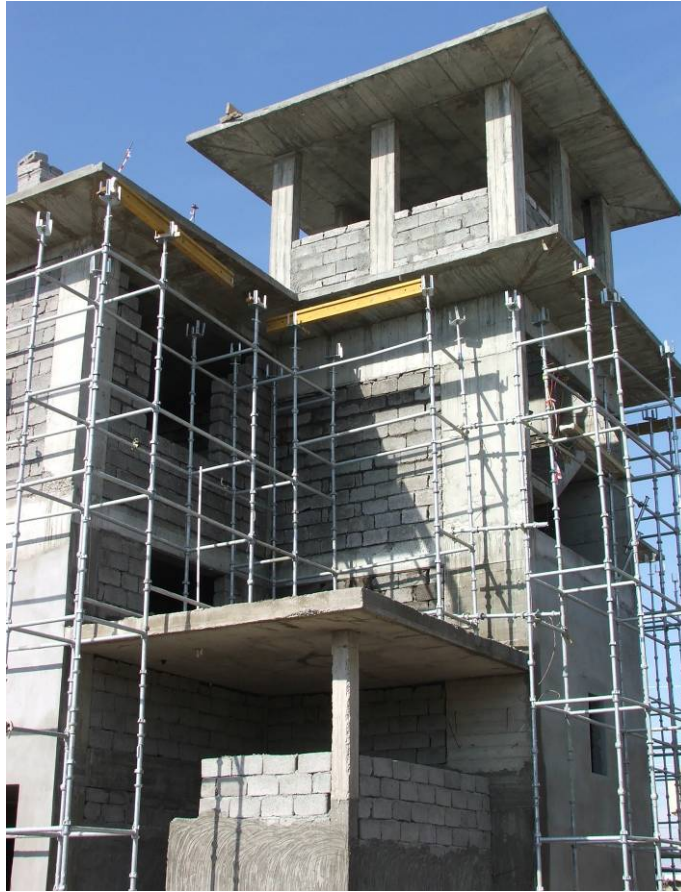
Site Photo 11. Exterior view of staircase # 1

We inspected the staircases from level 1 to the roof level and determined the rise and run of the steps were adequate and consistent with the design.

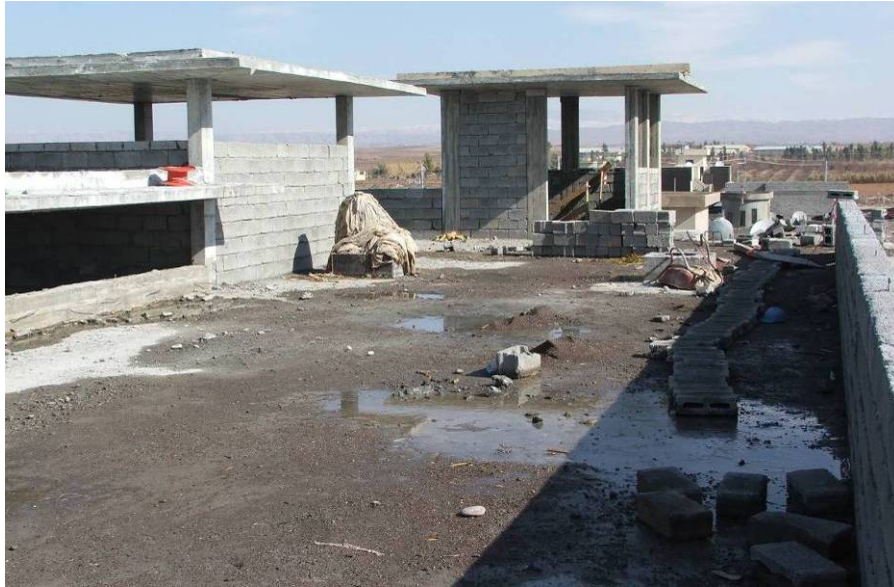
The roof was partially constructed at the time of our assessment. The roof design consisted of a reinforced concrete slab and a perimeter parapet. The roof also contained additional concrete roof slabs for the staircases, a shelter for two water tanks, and a roof light (skylight). Additionally to complete the roof, the design required an insulating layer of sand underneath 400 mm x 400 mm concrete panels sealed with an asphalt bituminous joint compound. For drainage, the design required the main roof to be sloped from the middle to a perimeter edge channel with outlets in the corners. Exterior pipes would take the water down to ground level. As shown in Site Photo 12, construction consisted of a flat reinforced concrete slab and parapet with a central raised roof light, a water tank enclosure and a roof over the staircase. When we inspected the roof area, we did not find any noticeable problems or defects with the structural concrete or block work at this level.

Site Photo 12. Fire station roof construction

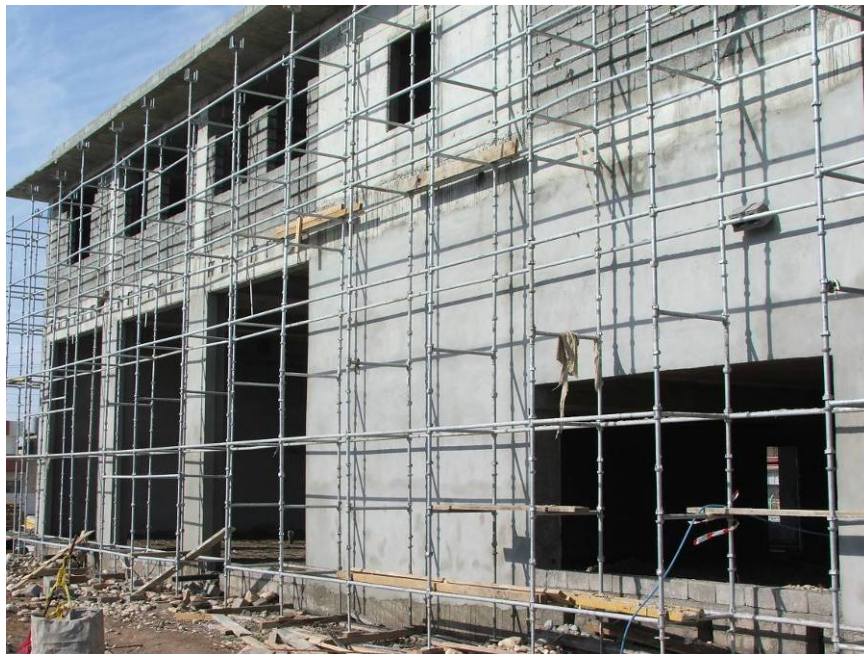
Site Photo 13. External concrete block wall construction on Level 3

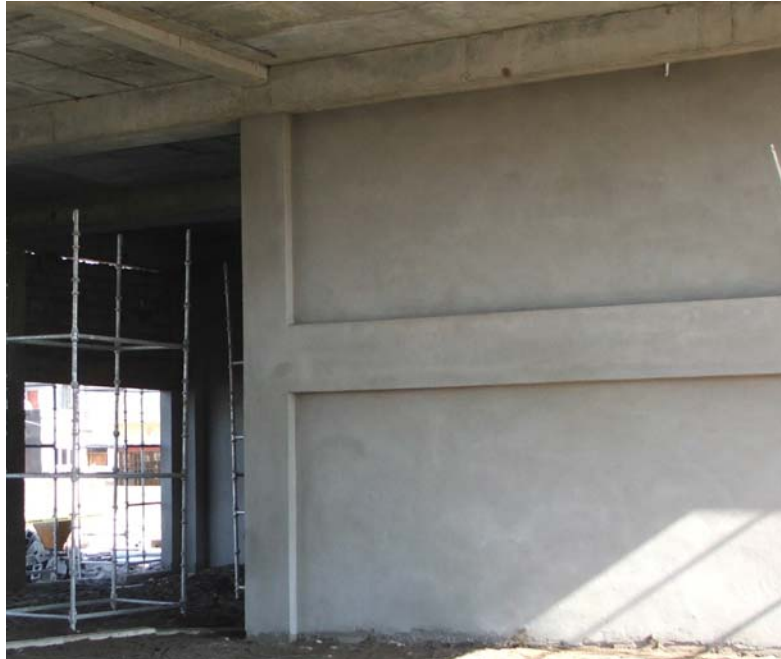
Site Photo 14. Finish coating applied to concrete surfaces on Level 1

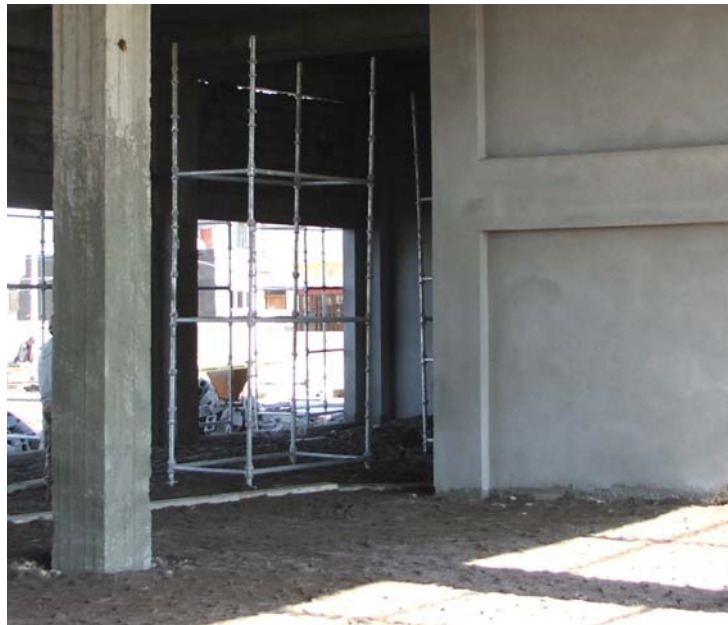
The design specifications for the reinforced concrete floor on Level 1 required a 200 mm thick reinforced concrete slab over a 150 mm thick consolidated hardcore (crushed aggregate) base. A damp proof membrane separates the hardcore and concrete. In addition, to fill in the voids within the hardcore and to create a smooth surface, the design called for a thin layer of fine material over the hardcore. At the time of our site assessment, the hardcore installation was in progress in Level 1. In the fire truck and SUV parking bays, the contractor had placed the hardcore and covered it with a layer of fine material. In the other areas, the hardcore was in place, but had not yet been covered with the fine material layer. Site Photo 16 provides an illustration of the fine material covering the hardcore in the fire truck parking bays. The work in Level 1 appeared to meet the contract requirements.

Site Photo 16. Base Preparation in Level 1 prior to floor slab construction
